TOWNSHIP OF LONG HILL SANITARY UTILITY SYSTEM ASSET EVALUATION & CAPITAL IMPROVEMENT PLAN

January 2017

Prepared By:
Remington & Vernick Engineers
232 Kings Highway
Haddonfield, NJ 08033
856-795-9595

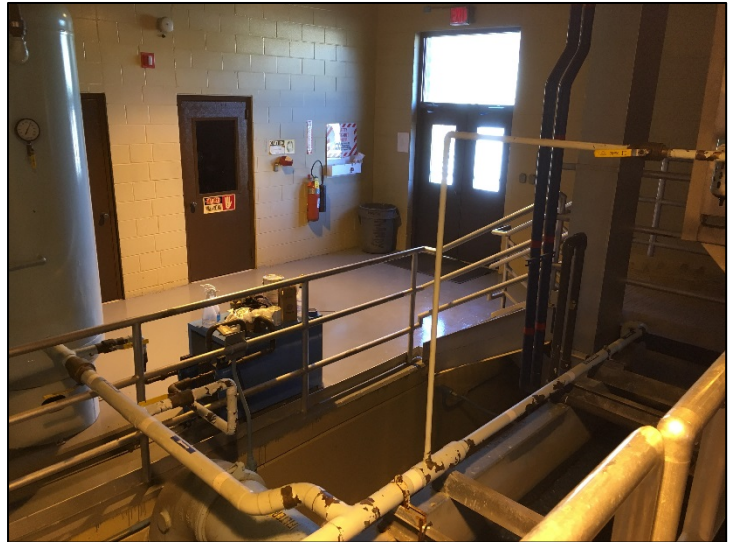
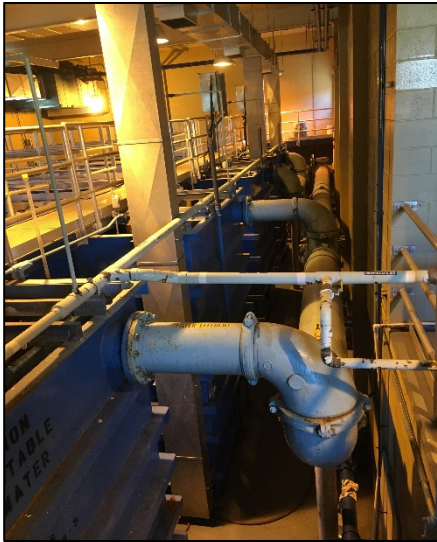
Photo #103 – Sand filter effluent piping

Photo #104 – Air tank and piping to sand filters

As noted previously, the waste stream that exits the clarifiers is sent to the Filter Room. The Filter Room consists of four (4) Parkson Dynasand continuous backwash sand filters. The filters were designed to be continuously backwashed with no screens. The sand filter tanks have an internal vertical airlift that is supplied by the compressed air tank and piping shown Photo #104 above. The four sand filters each have six (6) air lifts for a total of 24 air lifts in the filter system. The air lifts are prone to holes due to the sand abrasion. The utility replaces the air lifts when they are no longer lifting. For planning purposes, two (2) air lifts should be budgeted to be replaced each year.

At the time of inspection, Sand Filter No. 4 was losing sand and the tank should be replaced or repaired. Due to the abrasion experienced due to the air lift operation, the Township should anticipate repairing or replacing at least one additional sand filter tank over the 20 year planning period.

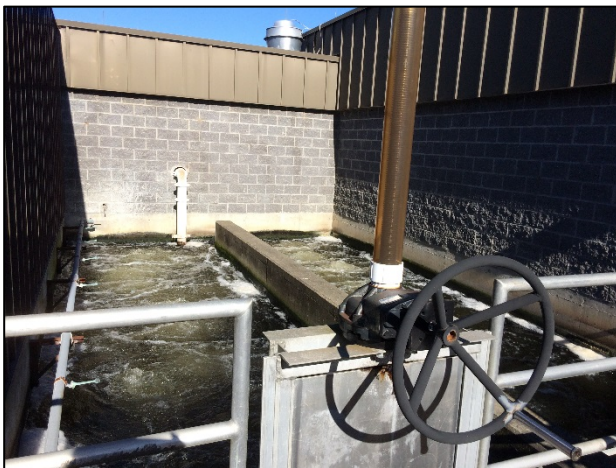
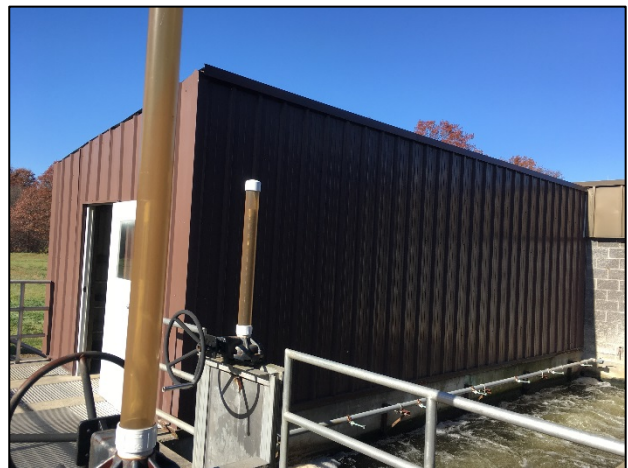
Photo #105 – Post Aeration Channel

Photo #106 – Post aeration with UV building

Post sand filtration, the effluent enters an open air concrete tank. There are two (2) blowers; one 10 HP and one 88.5 HP. The blowers serve the 28 coarse bubble diffusers spaced at 2' intervals and provide the additional oxygen in the filtered effluent to meet NJDEP dissolved oxygen concentrations. The blowers are 10 years old and there are currently no issues with the size or function. However,

the blower motors are aging and should be replaced.

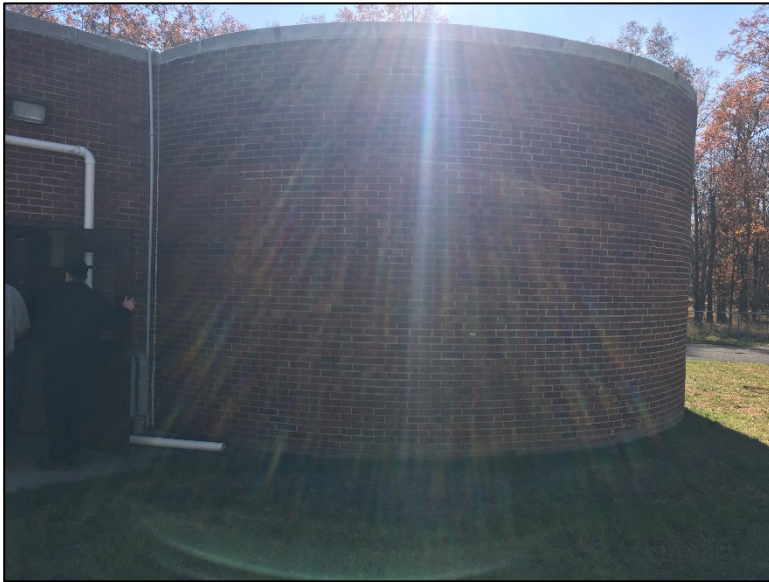
Photo #112 – Sludge Building / Tank

The sludge building is the original structure of the treatment plant and is located closest to the river. The building is prone to flooding and flood gates should be provided for the building to protect from water infiltration and preserve the equipment and treatment operation. Currently, the utility must disconnect equipment and place on blocks prior to an anticipated flood event. This is disruptive to operations and the treatment process.

One of the tanks (Tank No. 2) receives waste activated sludge by way of the waste activated sludge pumps. The other tank (Tank No. 1) receives thickened waste activated sludge from the mechanical thickener located in the building. The digester tanks are original construction and were part of the original plant. Coping stones around the base of the tank should be replaced / repaired. Also the tanks should be drained, cleaned and the interior recoated to protect the structure.

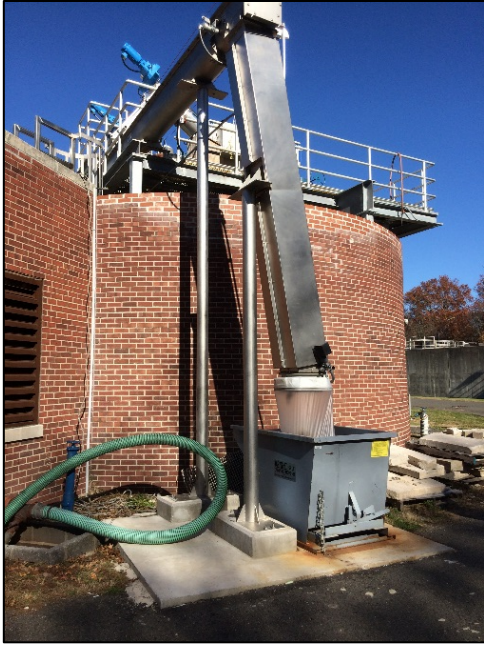
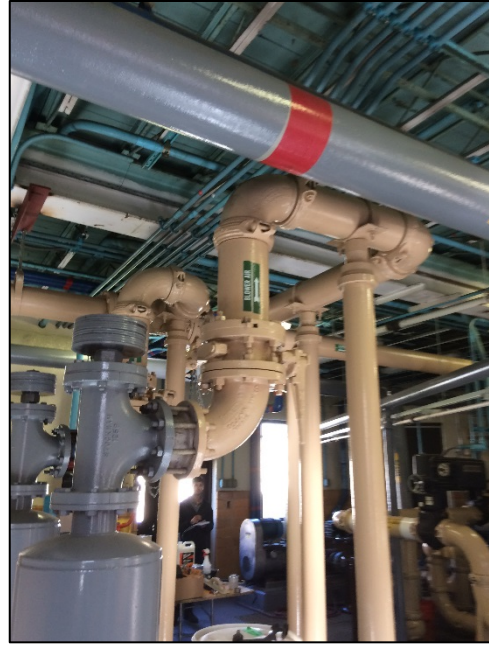
Photo #113 – Screw press and screenings dumpster Photo #114 – Sludge Building / Tank

There are two (2) sludge thickening pumps which are past due for replacement. Accordingly, this work including a minimum of two (2) additional pumps replacements should be considered during the 20-Year planning period.

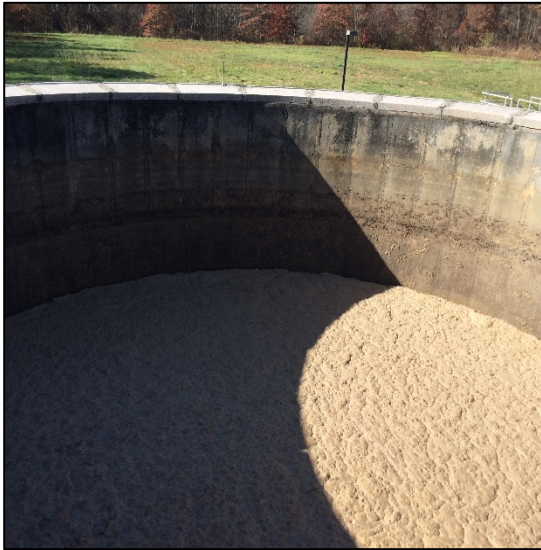
Photo #115 – Digester Tank

Includes in the building are two (2) sludge transfer pumps. Neither of these pumps are utilized since sludge is transferred by gravity flow instead.

- UV Disinfection – automatic actuators;
- Outfall – clear surrounding area, as permitted by governing agencies;
- Sludge Building – install flood gates;
- Sludge Building – replace two (2) sludge thickening pumps (3 times during planning period);
- Sludge Building – replace polymer tank;
- Sludge Building – replace blowers;
- Sludge Building – repair roof / scuppers;
- Sludge Digester Tanks – repair structure / coping stones;
- Sludge Digester Tanks – empty, clean and recoat;
- Fuel Storage Building – replace fuel pumps (twice during planning period);
- Fuel Storage Building – install ventilation.

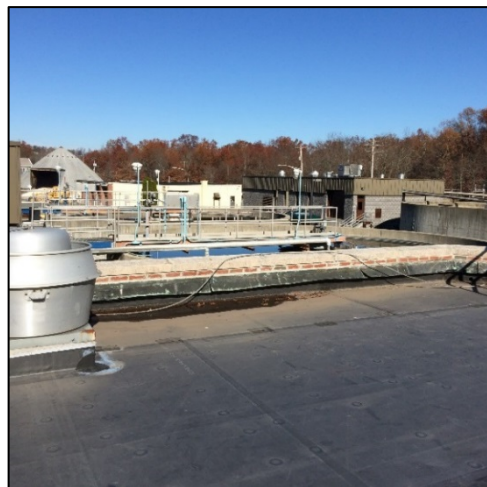
Photo #117 & #118 – Sludge Building / Tank – ponding water on roof

At the roof level, an aluminum framed platform and stairs with fiberglass grating and aluminum handrail provide access to the sludge pump controls. Although the roof is newer, significant ponding was noticed at the time of inspection around the

drainage scuppers located 1-2 inches above the roof surface. As the scuppers are the only source of drainage for the flat roof, this area should be re-sloped, or the scuppers enlarged to conduct flow and minimize standing water.

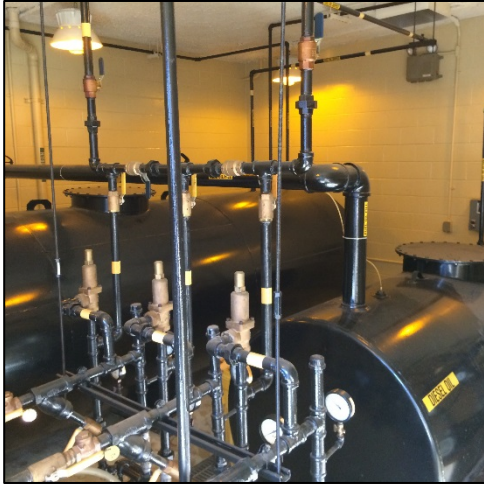
Photo #119 – fuel storage tanks and piping

Based upon records provided by the utility, tanks are filled every 2-3 months. The pumps for the tanks are older in nature and should be replaced. In addition, ventilation should be added to the building to remediate the combustible fumes emitted from the tanks.
